Quinquennial Inspection Report

The Church of the Ascension, Hall Green in the Diocese of Birmingham

Issue date: June 2019
Prepared by: Libby Watts
Checked by: Christopher Thomas

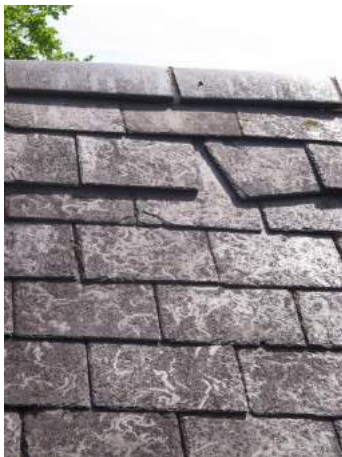
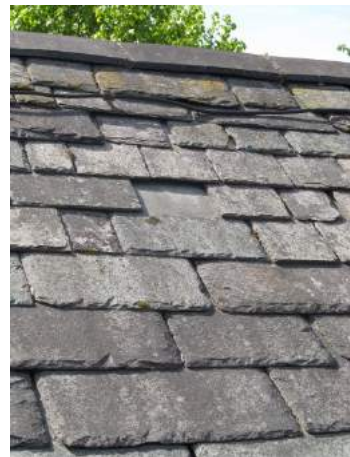
3. There are one or two slipped or missing slates needing repairs.

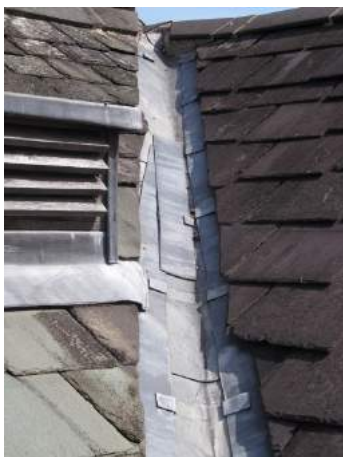
4. Two sacrificial lead strips to the south transept/nave roof pitched gutter are loose and need re-fixing.

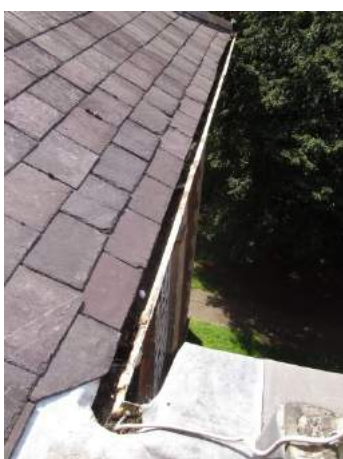
6. The transept gutters need cleaning.

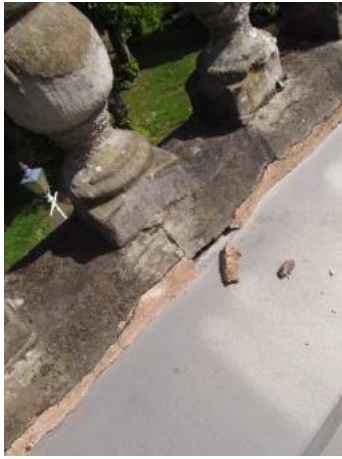
7. It is noted that areas of the mortar pointing to the cover flashings to the parapet gutters are failing. Defective sections should be raked out and repointed to at least a depth of 10mm. If the problem persists, it may be better to remove the mortar and form the joints in an appropriately coloured mastic.

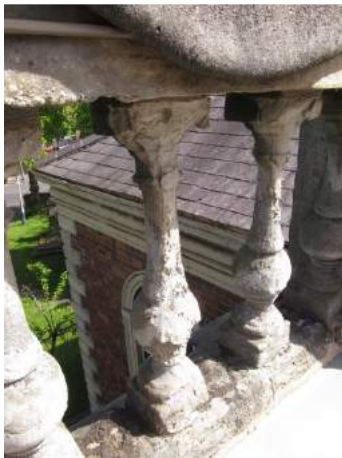
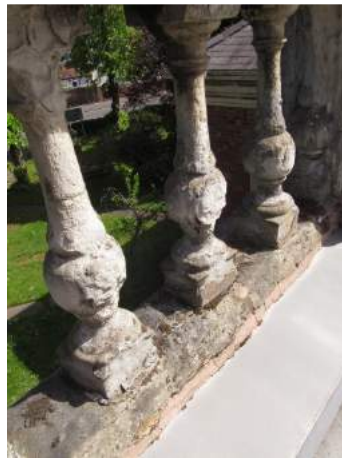
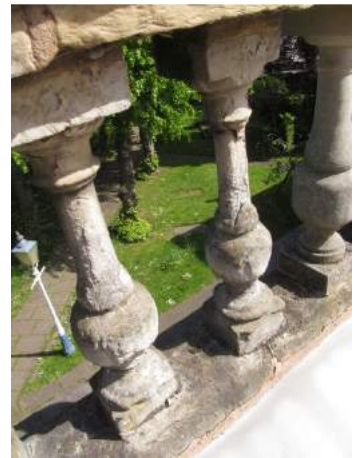
8. A number of the stone balusters are heavily eroded, particularly to the north elevation. These will need to be removed and replaced.

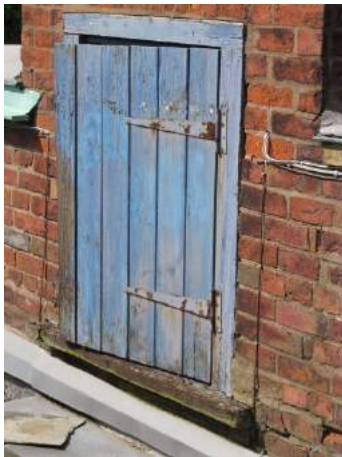
10. The access door and frame onto the roof is in need of repair and redecoration.

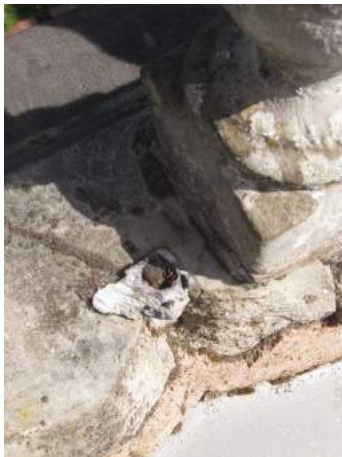
11. There is a small section of redundant ferrous metal projecting from the stone and the base of the balustrade to the central bay to the north elevation, which is causing disruption. This should be removed and the stone repaired.

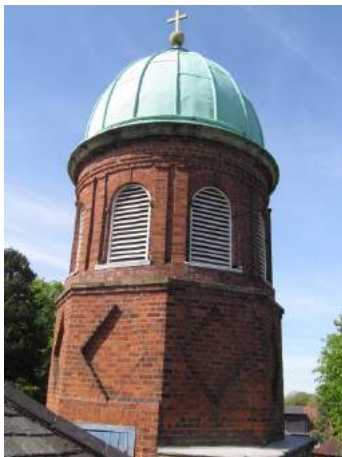
1. The tower is topped by a copper covered dome surmounted by a gilded cross and ball. Cross, ball and copper all appear sound. Minor rust staining and some minor stress cracking on the vertical roll joints. Gilding to cross and ball is largely lost. The asphalt roofing abutting is cracked on the south side and needs mastic pointing.

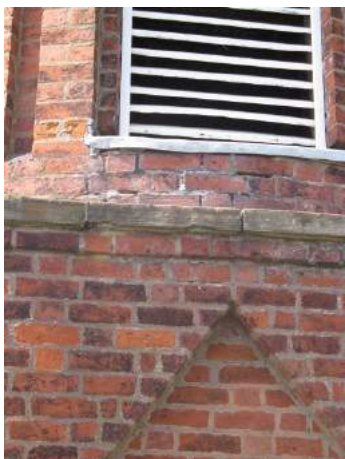
2. There are one or two open joints to the brickwork of the tower.

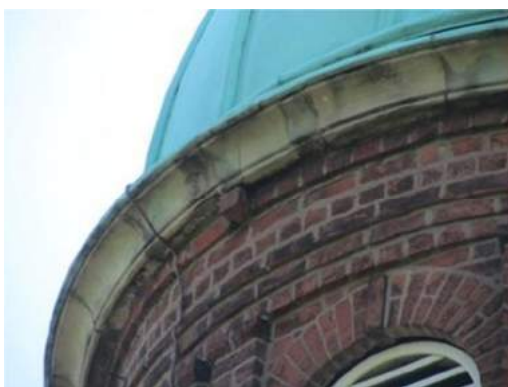
3. Fine crack to one section of the upper stone corbelling.

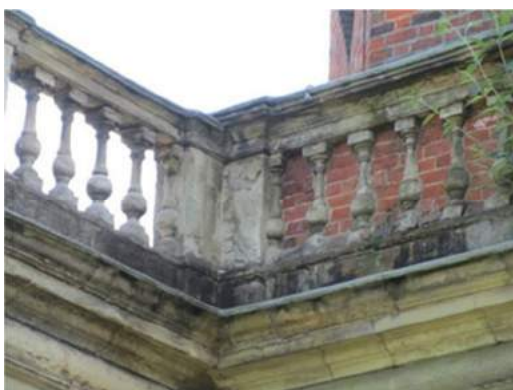
4. Heavy erosion to sections of the stone blind balustrading, particularly in the east corner. Open joints noted to the brick and stonework at the base of the balustrading.

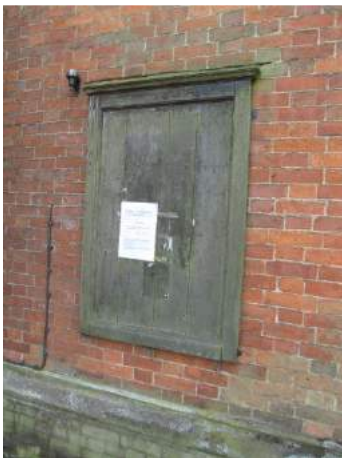
6. The noticeboard to the north face is in need of overhaul and treating with Danish oil.

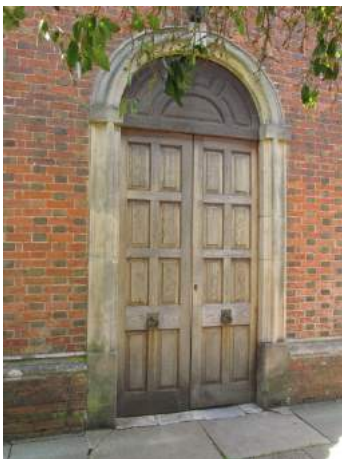
7. The west door is in good condition but a repair is needed around the keystone where a small section is likely to fall.

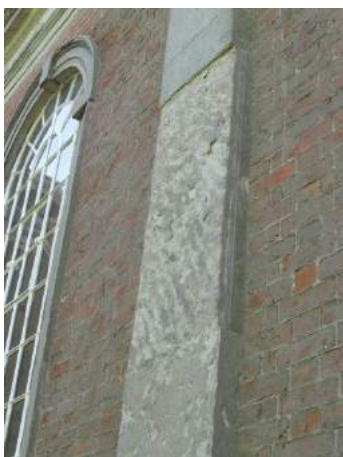
1. The nave is of brick construction with sandstone cornice and frieze, pilasters, plinth offset, window surrounds and upper balustrade. The stone dressings are in variable condition. There is notable erosion to moulded features at high level, and there are several eroded ballusters to the parapet. A number of the lower quoins have been repaired using a mortar facing which is failing in areas. Areas of the pilasters are laminating where stone have been face bedded.

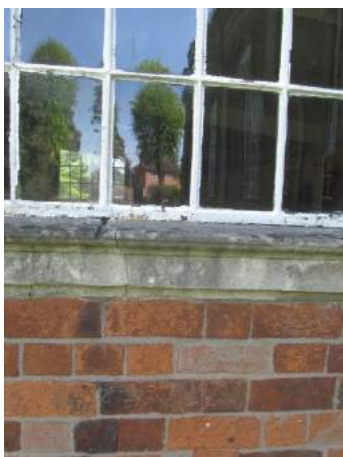
2. There is a single window, which is in need of redecoration and treating for slight rust and a cast iron downpipe and hopper, also in good order. Slight rusting to the cast iron guttering.

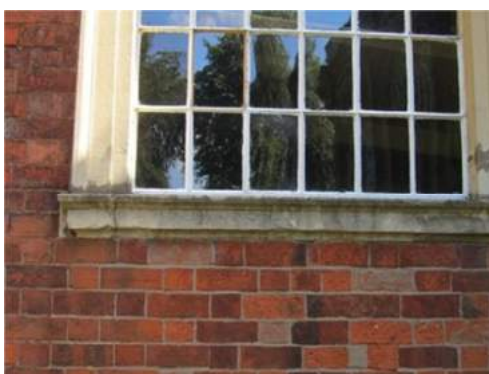
2. There is fine cracking through the stone window cill.

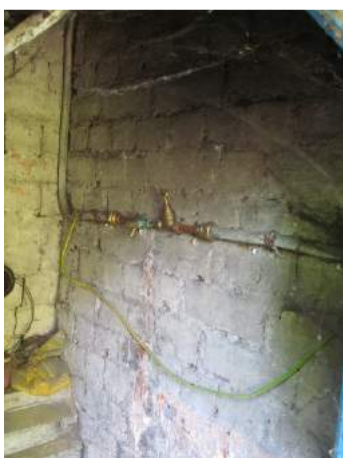
1. Contains 2 doorways, one into the gallery access stair, one to below stair storage. Access was available to the lower door and rubbish should be cleared and insulation applied to water pipework. Stone surrounds to doorways, and stone dressings generally are in reasonable condition. Slight rusting to the cast iron guttering.

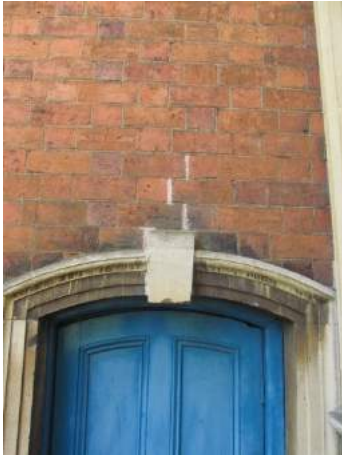
2. Cracking through the joints of the brickwork down to the head of the lower doorway has been repointed and shows no further signs of movement.

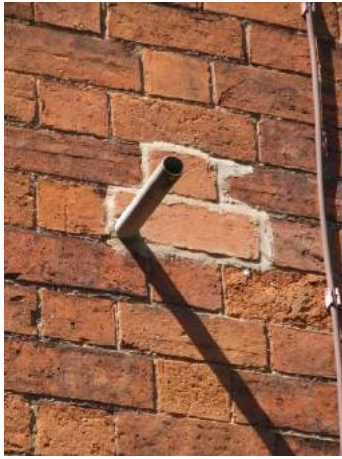
1. Contains a small round window which is in good order. Minor isolated open joints to the brickwork. Poor patch of replacement brick over the overflow pipe. Open joints to the stone plinth offset. Slight rusting to cast iron gutter. Cast iron downpipe in good order but gulley below is blocked.

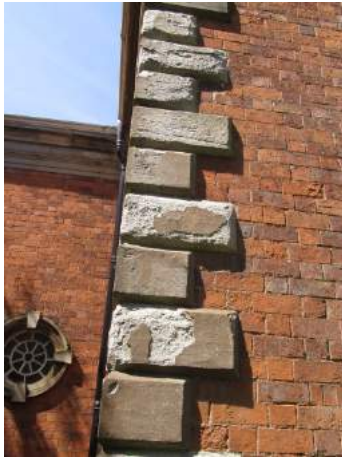
1. Contains the stained glass east window which is guarded and in good order. Slight rusting to the cast iron guttering. Brickwork and stone dressings largely in good order, but with some erosion to the stone quoins.

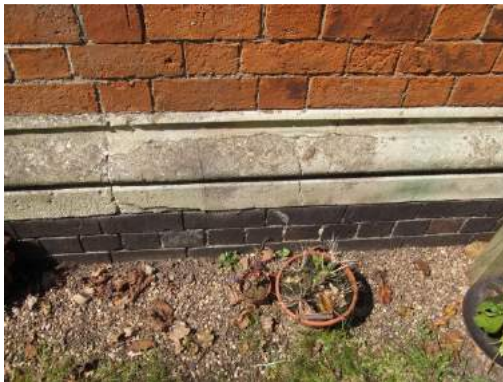
2. Minor open joints and fine cracking through the stone plinth offset.

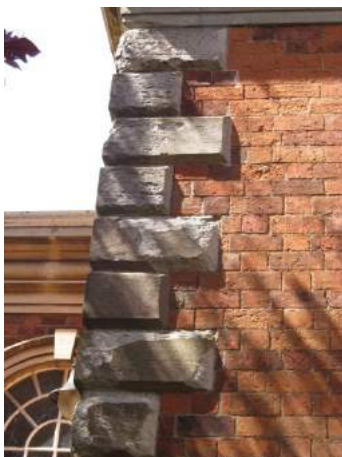
1. Contains a small round window which is in good order. Minor isolated open joints to the brickwork. Erosion to the higher level stone quoins. Slight rusting to the cast iron guttering. Cast iron downpipe in good order but gulley is blocked.

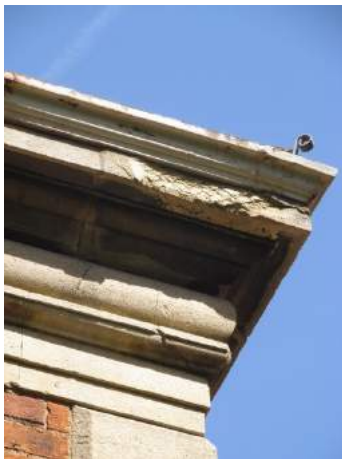
1. Single doorway with round window over, both with stone surrounds. Stone dressings generally in reasonable order with the exception of the corbel stone in the south east corner which needs repair.

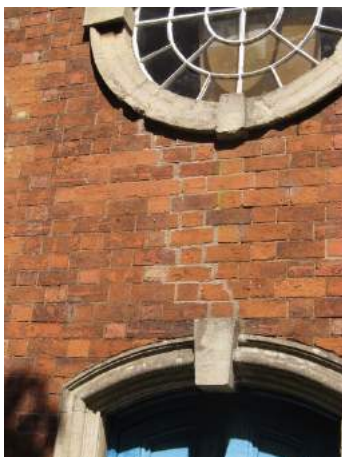
2. Isolated open joints to low level brickwork. Slight rusting to cast iron gutter.
3. Vertical crack running through the brickwork from the key stone over the doorway to the base of the window above. Repointed and shows no further movement.

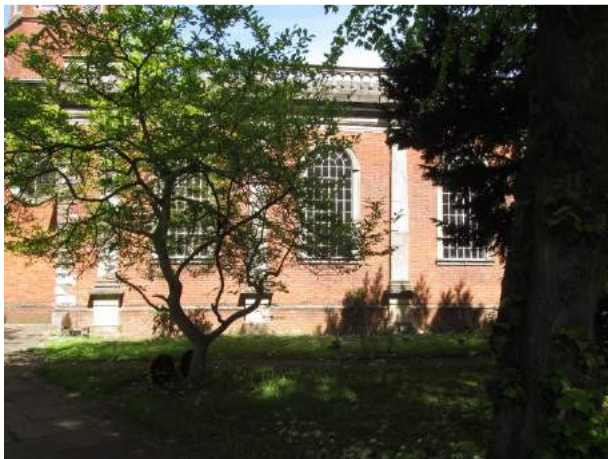
1. As north elevation. There is extensive erosion to sections of the high level stonework, and face bedded sections of stone to pilasters and balustrade are delaminating.

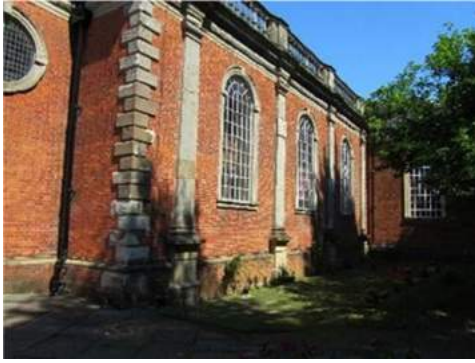
2. A number of the lower sections of stone have been repaired using a mortar facing which is now failing in areas.

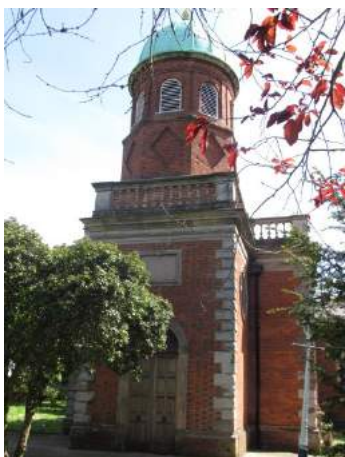
1. The stone plaque above the west door has been consolidated. The inscription should be recorded if not already done.

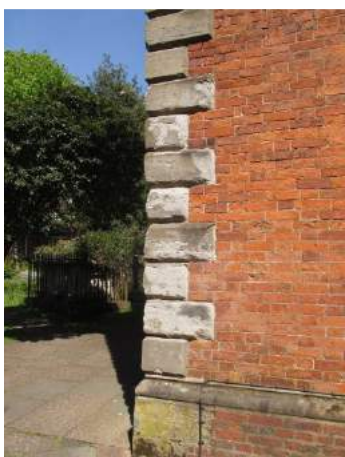
2. Generally brickwork and stone dressings are as elsewhere in reasonable condition although there is notable deterioration to the stone quoins to the elevation.

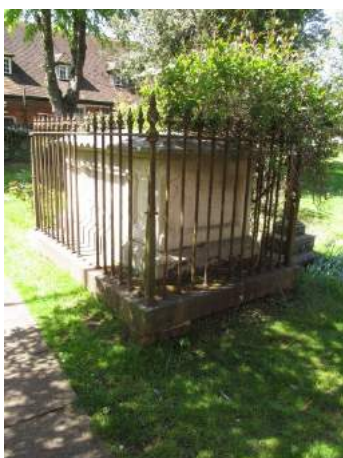
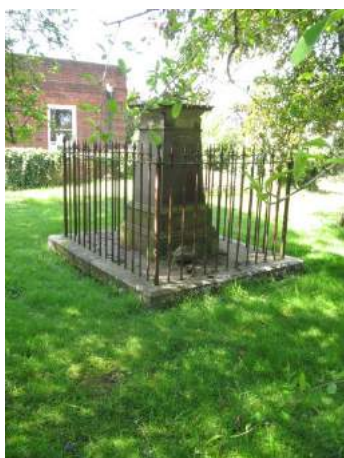
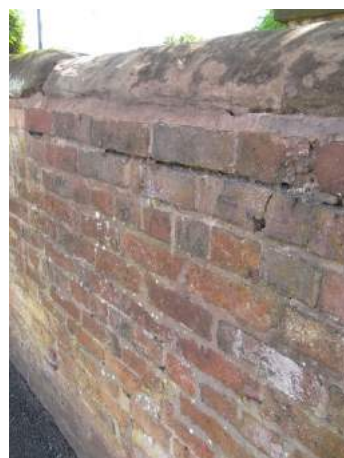
3. There are a number of tombs with iron railings in the churchyard which would benefit from conservation and repair, but none appear to be in an unsafe condition.

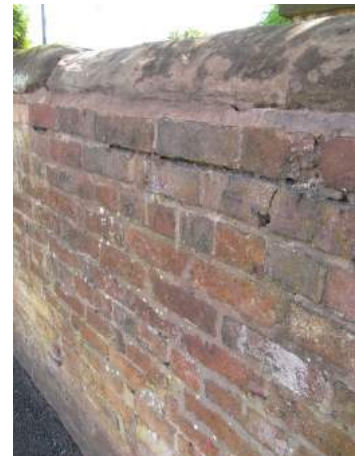
5. The boundary walls around the church are largely of red brick with half round sandstone copings. These are generally sound, but some sections are leaning due to the proximity of mature trees, particularly along the east boundary along Fox Hollies Road. There are sections of missing pointing to the brickwork and to the bedding joints to the copings. Some copings are dislodged and others will need to be renewed in due course.

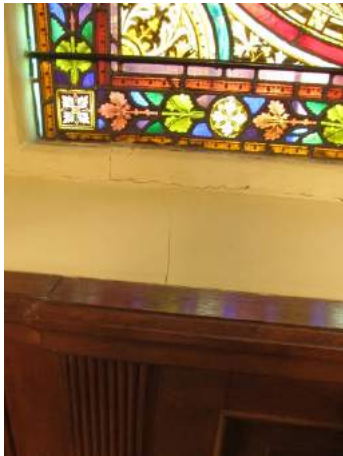
4. Fine cracks through the plastered cill to the north facing window. Fine crack at the abutment between the north and east coved ceilings.

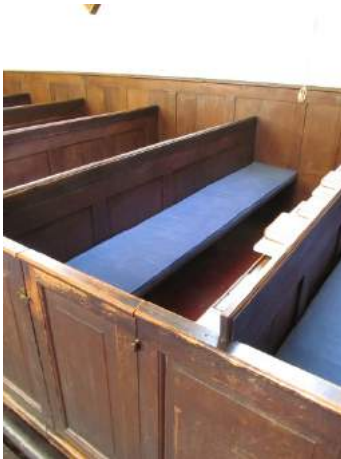
2. Mixture of stained softwood and oak pews all generally in good order. The bases of the external walls are covered by timber panelling, obscuring any damp, however there is no evidence of deterioration caused by damp to the panelling itself.

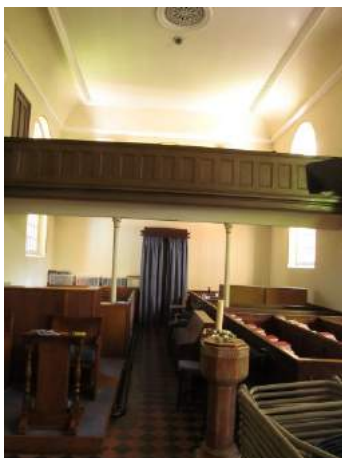
1. Central aisle is tiled, raised timber pew platforms either side. 1 loose floor tile adjacent to the organ console. Otherwise sound.

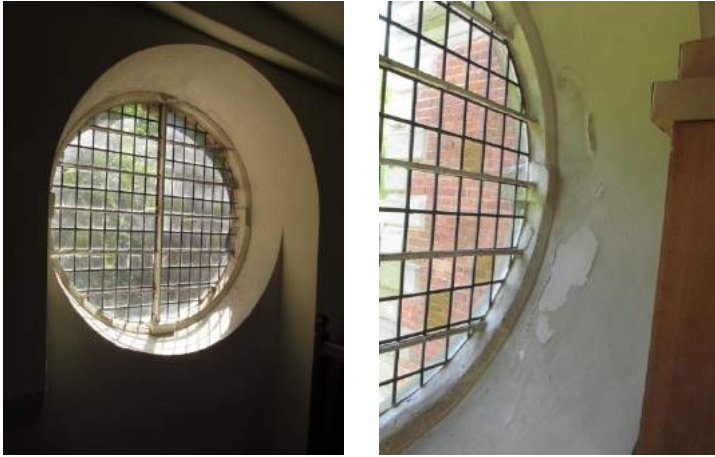
4. Flaking decorations around the north and south round windows at landing level indicating some dampness within the walls. 1 or 2 cracked panes to each window.

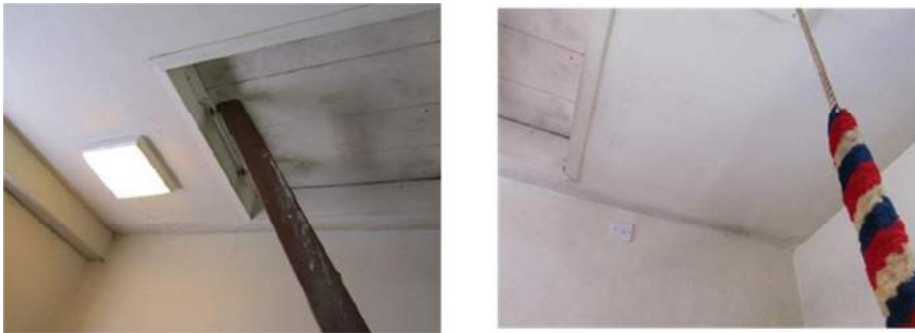
5. Cracking to the plaster ceiling above the upper landing, to the walls above the round windows, and down to the head of the door onto the west gallery.

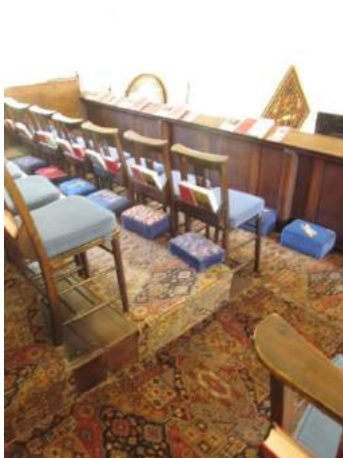
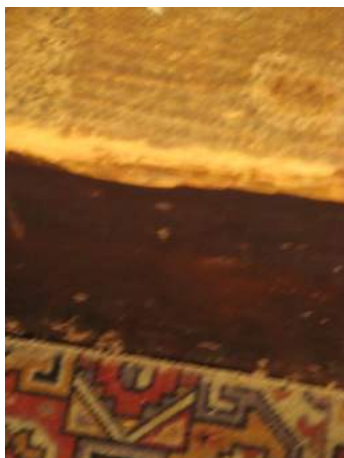
1. Tiered timber floor, oak panelled frontal approximately 800mm high which is lower than that required by the building regulations (1100mm). Some old woodworm damage to the floors and panelling. Does not appear to be active.
