Quinquennial Inspection Report

The Church of the Ascension, Hall Green in the Diocese of Birmingham

Issue date: June 2019
Prepared by: Libby Watts
Checked by: Christopher Thomas

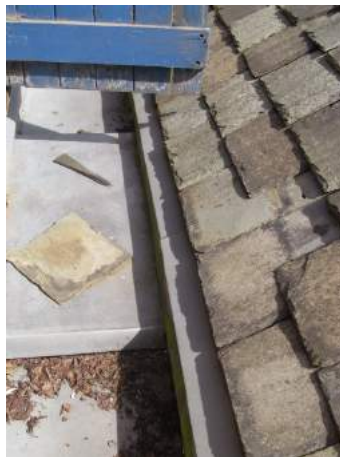
3. There are one or two slipped or missing slates needing repairs.

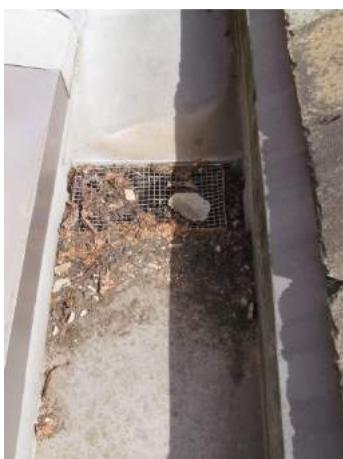
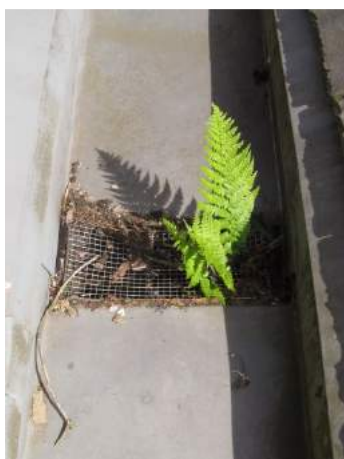
5. The parapet gutters and cess boxes need cleaning.

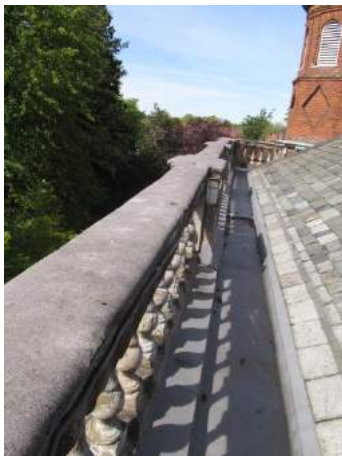
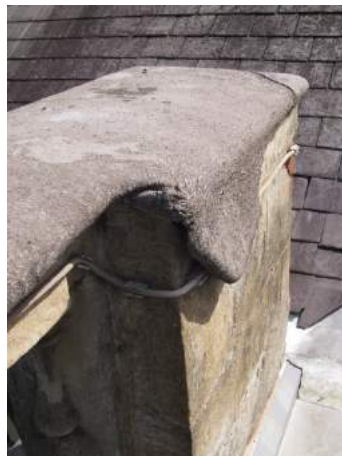
9. The stone parapet capping has been replaced with asphalt which is cracking slightly in some parts and slumping on the north elevation.

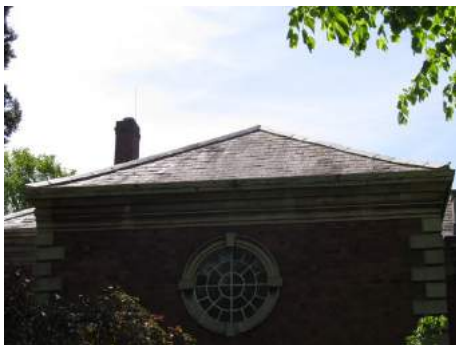
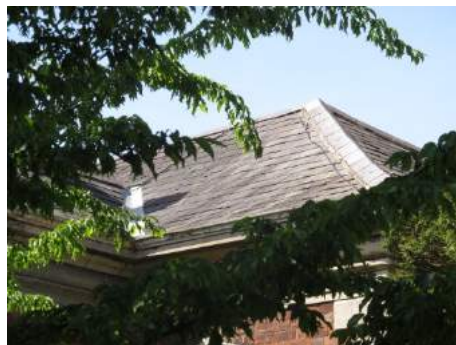
1. The north transept roof consists of a pitched, hipped roof with welsh slate, and clay ridge and hip tiles, discharging into cast iron gutters. All visible areas of slate appear sound. Slight rusting to the guttering. No access available to the pitched gutters at the chancel and vestry roof abutments.

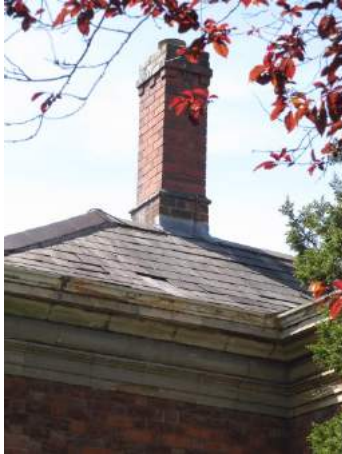
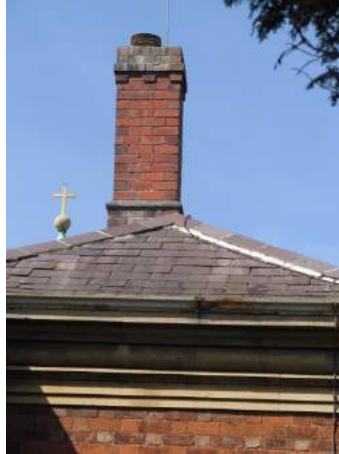
1. The vestry roof is a pitched roof with a hip to east end, which runs parallel to the chancel roof and runs into the east pitch of the north transept roof. It is clad in welsh slate, with clay hip and ridge tiles, discharging into cast iron guttering. No access available to the south pitch for inspection. Slight rusting to guttering as elsewhere. One slipped slate and pointing falling out of hip tiles.

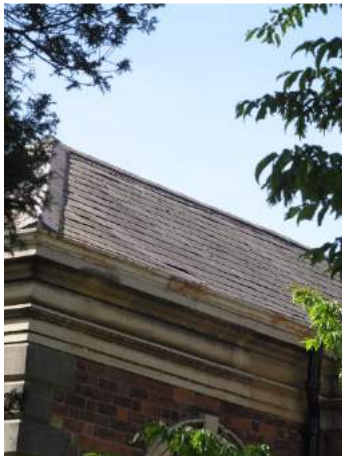
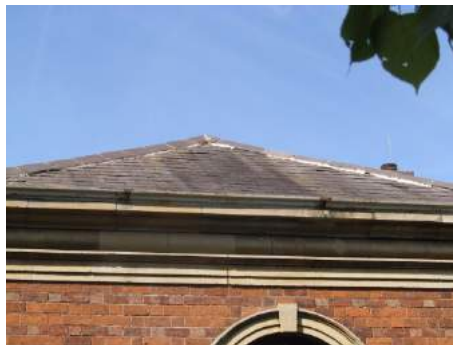
1. The chancel roof is a pitched roof with a hip to east end, which runs into the north and south transept roofs. It is clad in welsh slate, with plain clay hip and ridge tiles, discharging into cast iron gutters. Slight rusting to the guttering as elsewhere. One slipped slate and some mortar falling out of hip tiles.

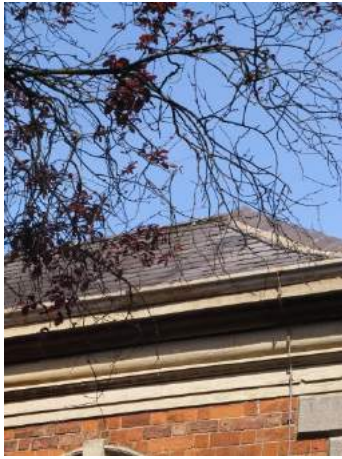
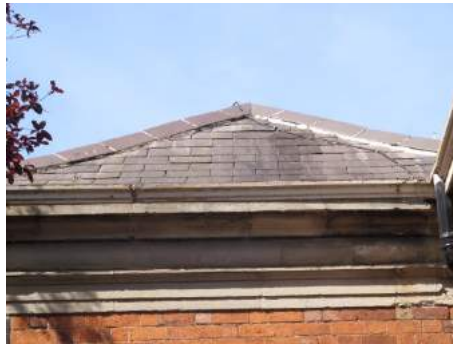
1. This roof matches that to the vestry of the north side. It is again clad in welsh slate, with clay ridge and hip tiles, discharging into cast iron gutters. Visible pitches appear sound. No access available to the north pitch for inspection. Slight rusting to the guttering as elsewhere.

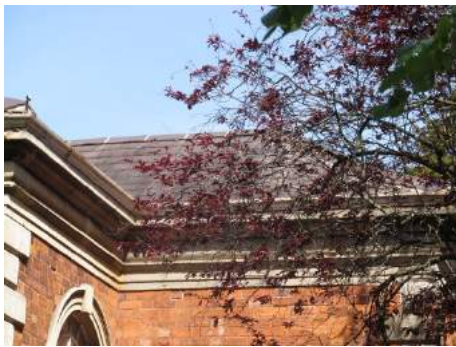
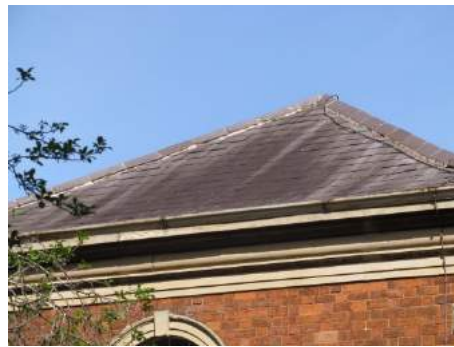
1. This roof matches that to the north transept and is again clad in welsh slate, with clay ridge and hip tiles, discharging into cast iron gutters. All visible areas of slate appear sound. Slight rusting to the guttering as elsewhere. One slipped slate and mortar falling out of ridge tiles.

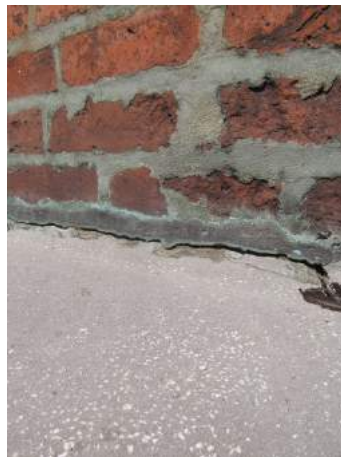
1. The tower is topped by a copper covered dome surmounted by a gilded cross and ball. Cross, ball and copper all appear sound. Minor rust staining and some minor stress cracking on the vertical roll joints. Gilding to cross and ball is largely lost. The asphalt roofing abutting is cracked on the south side and needs mastic pointing.

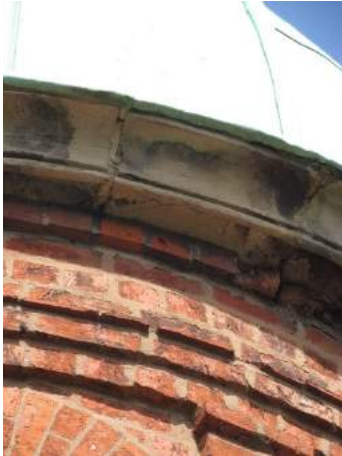
2. Some brick corbels to the tower roof bars are missing.

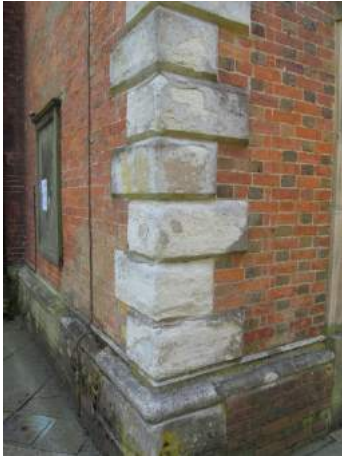
5. Some delamination to the quoin stones.

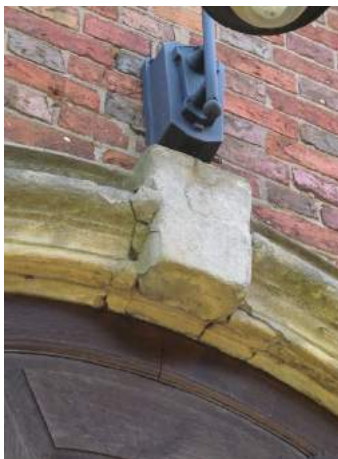
7. The west door is in good condition but a repair is needed around the keystone where a small section is likely to fall.

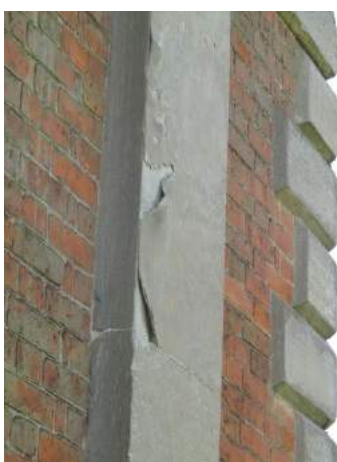
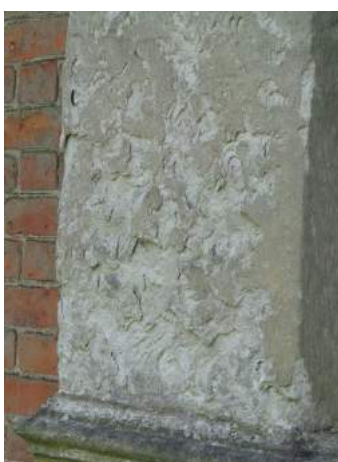
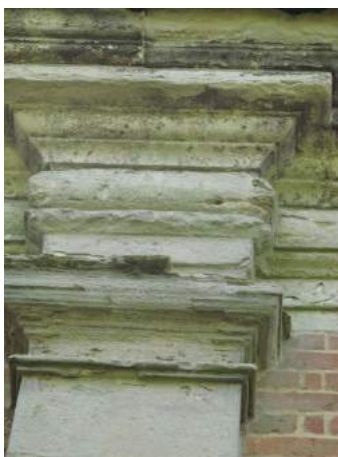
1. The nave is of brick construction with sandstone cornice and frieze, pilasters, plinth offset, window surrounds and upper balustrade. The stone dressings are in variable condition. There is notable erosion to moulded features at high level, and there are several eroded ballusters to the parapet. A number of the lower quoins have been repaired using a mortar facing which is failing in areas. Areas of the pilasters are laminating where stone have been face bedded.

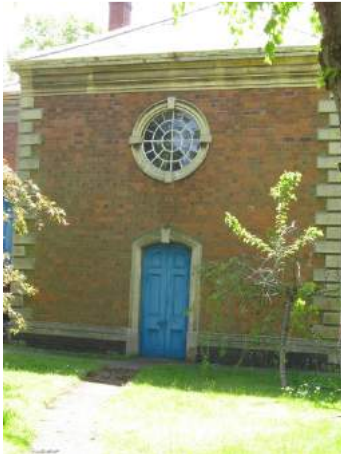
1. Central doorway, round window over. Isolated open joints to the brickwork. Stone dressings generally in reasonable condition. Window and door leaves in good order.

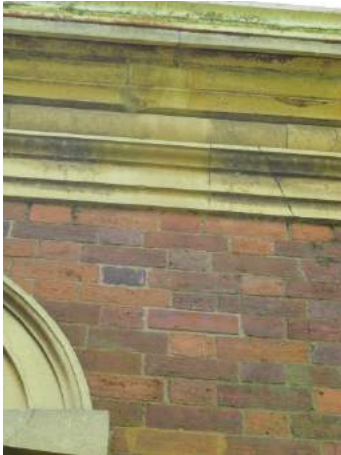
2. Fine cracking through the corbelled stone at the head of the wall, to the west of the window head.

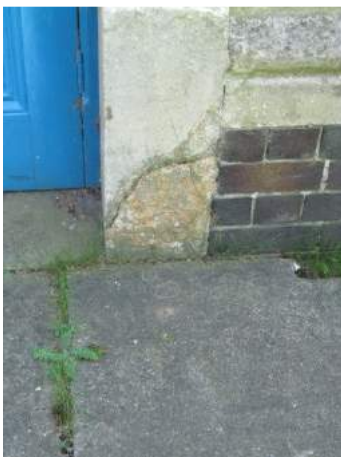
3. Patch repair to plinth block to right hand door jamb is deteriorating.

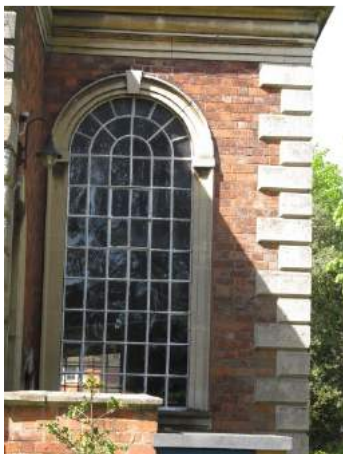
1. Single window is in good order. Slight rusting to cast iron gutter. Stone dressings in reasonable condition. Brickwork in good order with only minor isolated open joints.

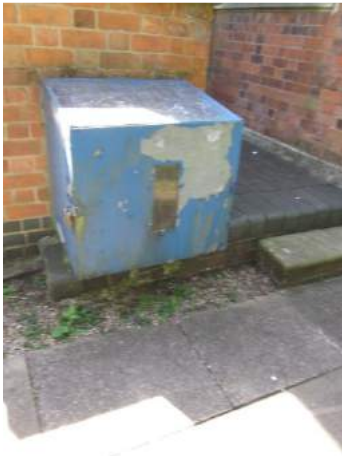
3. The gas meter cupboard needs redecoration.

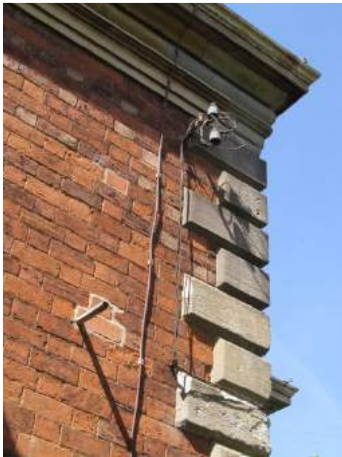
2. Redundant power cable and bracket should be removed.

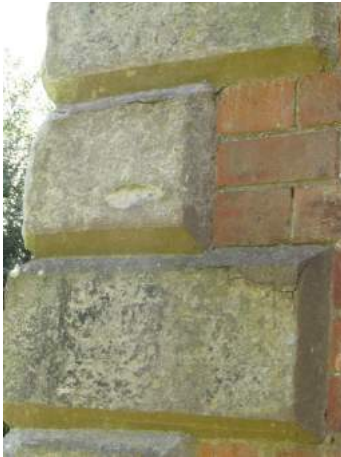
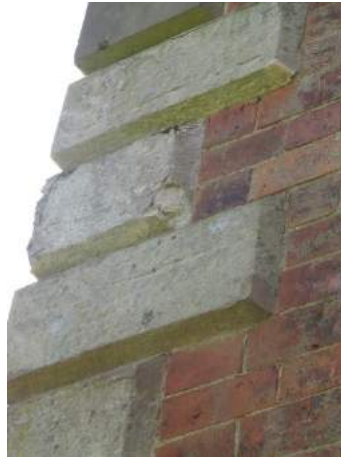
1. Minor erosion and cracking to the stone quoins, and isolated open joints to the brickwork. Slight rusting to the cast iron guttering. Single stained glass window guarded externally and in good order.

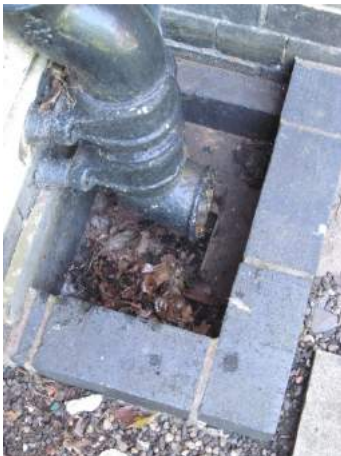
2. Blocked gulley needs cleaning.

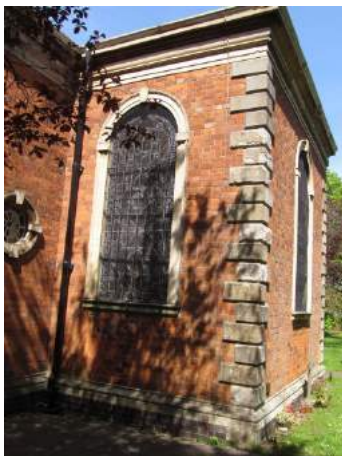
10.11 Chancel – South Elevation:

1. Contains a stained glass window guarded externally and in good order. Slight rusting to the cast iron guttering. Brickwork and stone dressings are largely in good order, but with some erosion to the stone quoins and to the section of stone corbel in the east corner.

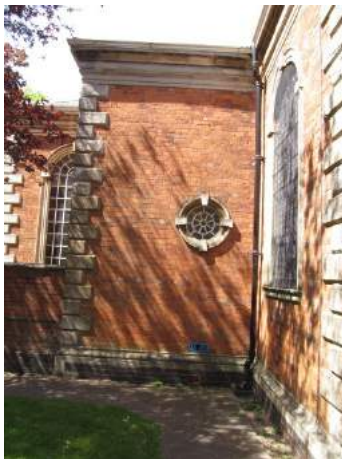
10.12 Chapel/South Gallery Access Stairs – East Elevation:

1. Contains a small round window which is in good order. Minor isolated open joints to the brickwork. Erosion to the higher level stone quoins. Slight rusting to the cast iron guttering. Cast iron downpipe in good order but gulley is blocked.

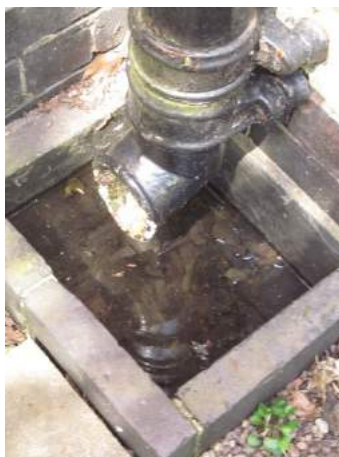
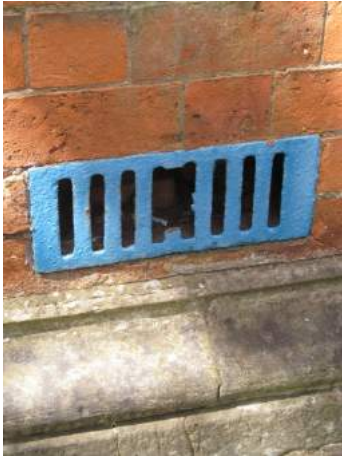
2. Vent grille damaged at low level.

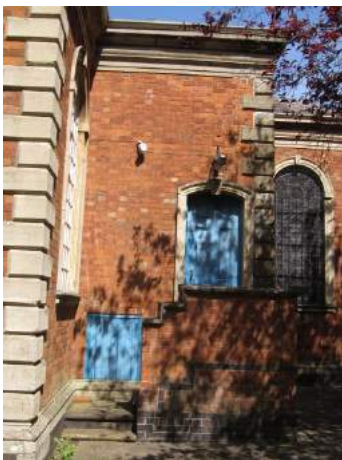
10.13 Chapel / South Gallery Access Stairs – South Elevation:

1. Upper doorway with stone surround into access stairs to south gallery. Lower access door appears to be a later addition and has no stone surround. All in good order.
2. Slight rusting to the cast iron gutter. Brickwork generally in good order. Slight erosion to the stone quoins.

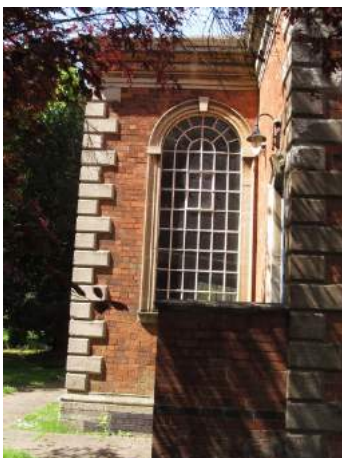
10.14 South Transept – East Elevation:

1. Single window in good order. Slight rusting to cast iron gutter. Stone dressings in reasonable condition. Brickwork in good order.

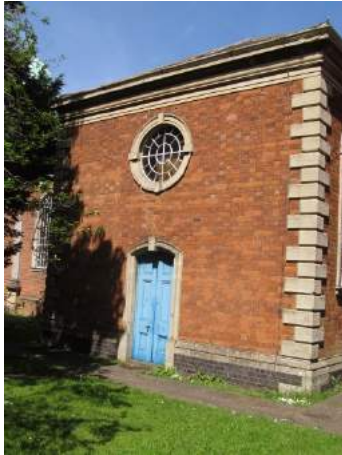
10.15 South Transept – South Elevation:

1. Single doorway with round window over, both with stone surrounds. Stone dressings generally in reasonable order with the exception of the corbel stone in the south east corner which needs repair.

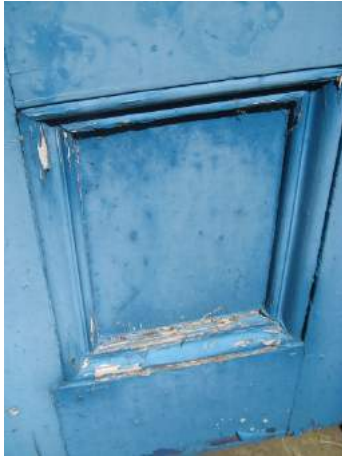
4. The door needs repair and redecoration.

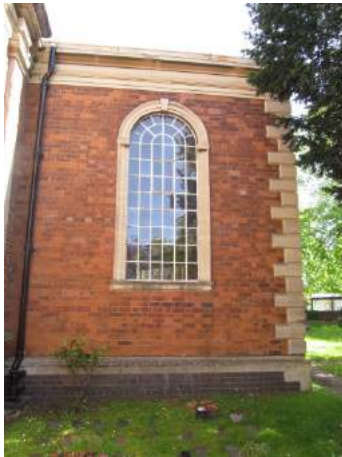
10.16 South Transept – West Elevation:

1. Single window with stone surround in good order. Cast iron downpipe in good order. Isolated open joints to the brickwork. Stone dressings generally in good order. Slight rusting to the cast iron gutter.

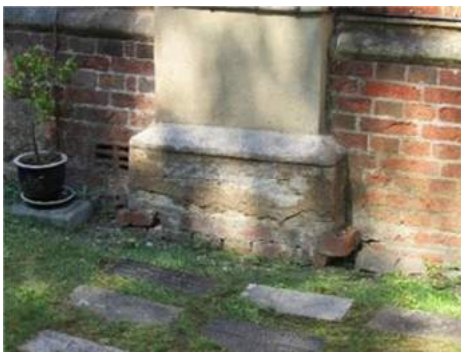
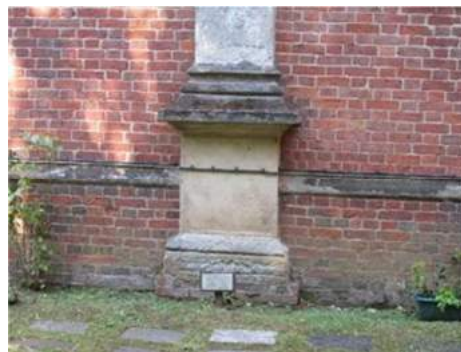
3. Brickwork is generally in good order. There is some disruption however to the brickwork at the bases of the pilasters, that to the West particularly, where bricks are disrupted at ground level, and there are open joints.

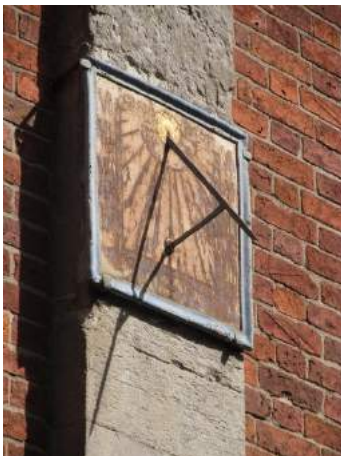
4. The sundial is an important feature of the church and needs careful redecoration.

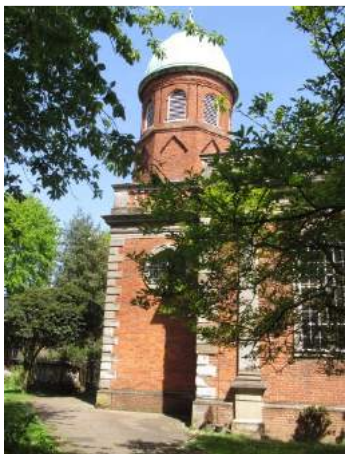
1. Small plants growing from the offset brickwork at the base of the blind balustrade. These should be removed, and the roots treated with an appropriate herbicide

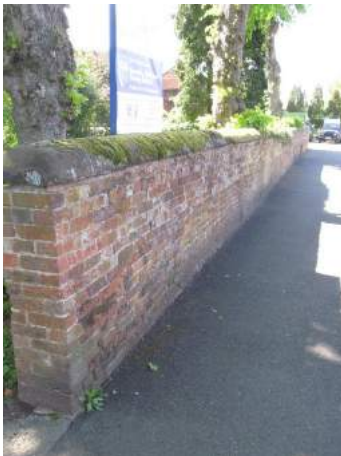
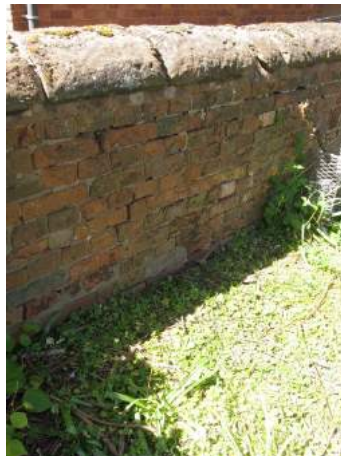
5. The boundary walls around the church are largely of red brick with half round sandstone copings. These are generally sound, but some sections are leaning due to the proximity of mature trees, particularly along the east boundary along Fox Hollies Road. There are sections of missing pointing to the brickwork and to the bedding joints to the copings. Some copings are dislodged and others will need to be renewed in due course.

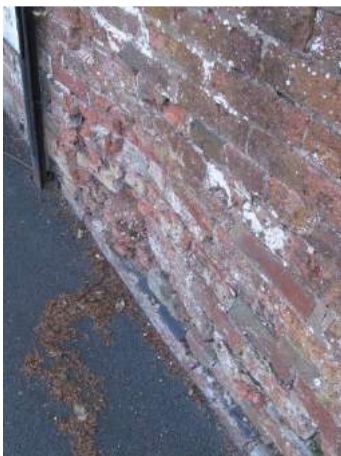
6. There is an area of impact damage to the east boundary wall needing careful repair.

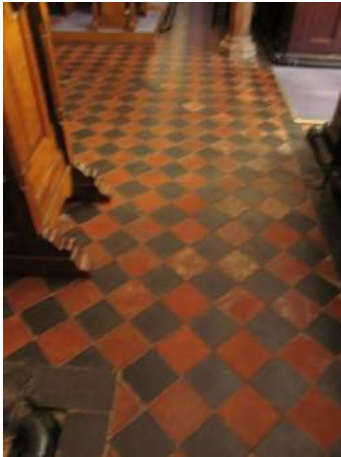
1. Central Aisle and open areas at east end are in black and terracotta quarry tiles, with a central carpet. Isolated loose tiles adjacent to the carpet, particularly on the north side. Softwood pew platforms to north and south, all in good order.

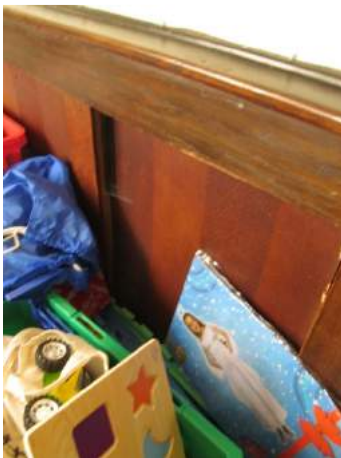
3. The replacement infill panels to the dado panelling to the south side of the west wall have come loose and should be secured. Otherwise, box pews and panelling are in good order.

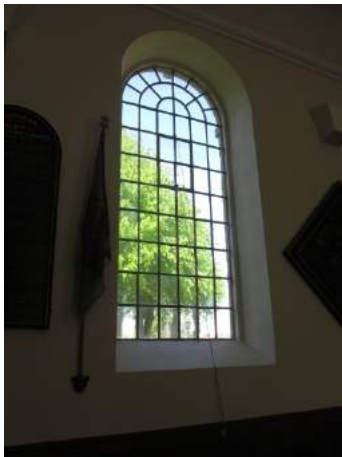
4. Windows are metal framed with clear, crown glass. Opening lights have been overhauled and are functional, frames themselves are in a good state of repair. There is one poorly matched replacement pane to the 2nd window from the west end off the north side. (W2).

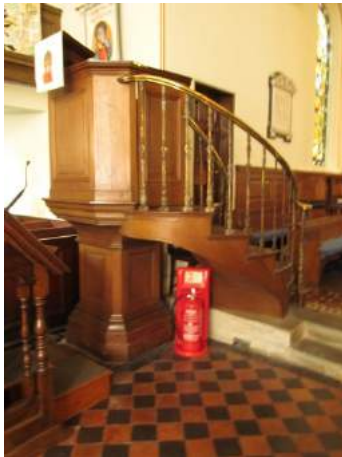
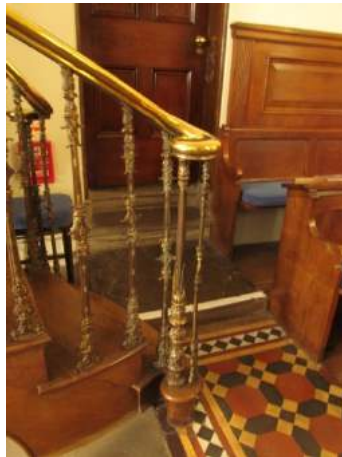
5. Oak pulpit is in good order. There is movement to the handrails and newell post which needs attention.

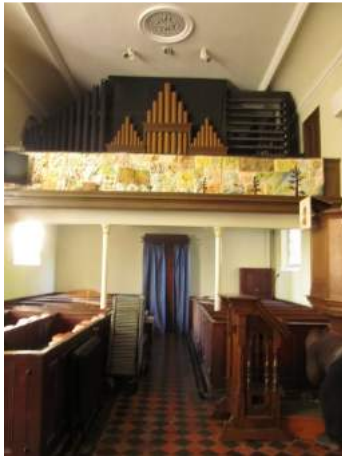
1. Central aisle is tiled, raised timber pew platforms either side. All in good order.

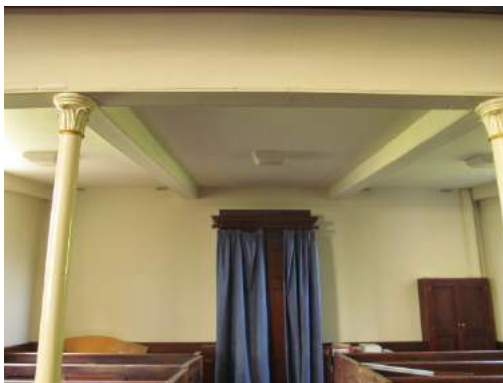
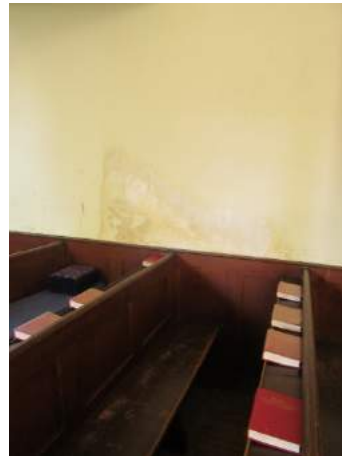
2. Plastered walls and underside of gallery over all in good order except for one patch on the east wall which needs further investigation.

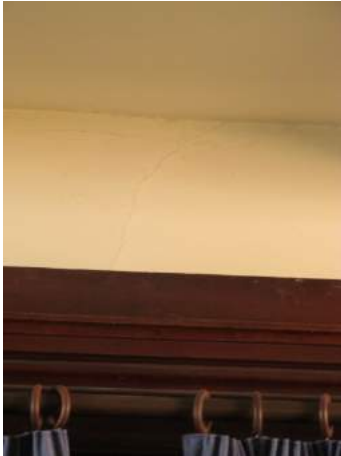
2. Vertical crack through the plaster above the head of the external door in the south wall.

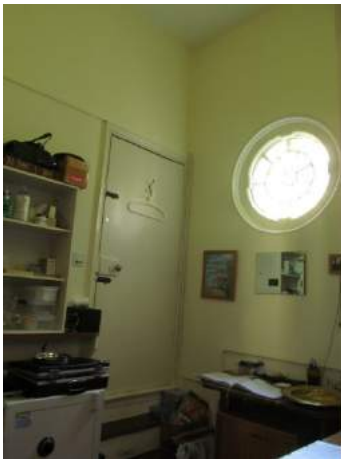
1. There is no natural ventilation in the Vestry.
2. Stairs to gallery are in good order. A small repair is needed to the lobby floor and matwell.

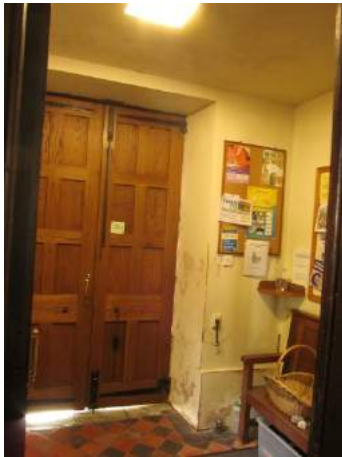
1. The lower parts of the west wall, either side of the main west door are damp, and there is paint loss and efflorescence, and rusting to the metal corner stops.

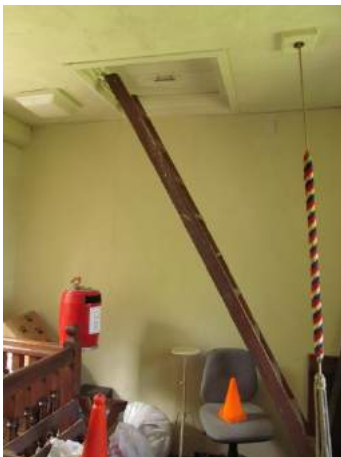
6. Access to the roof is gained via a fixed ladder off the upper landing through a ceiling hatch. All in good order and easily accessible.

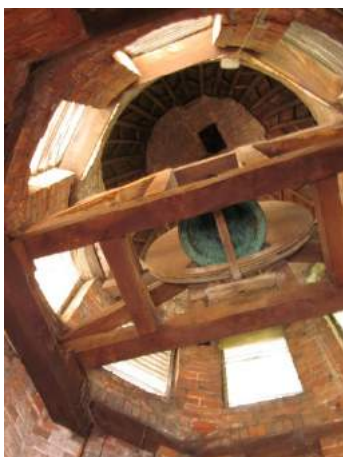
1. The upper lift of the tower is of exposed brickwork terminating in the timber structure of the dome. All louvred openings are protected with bird mesh, and there is no evidence of ingress.
2. The timber structure of the dome appears sound, as does the timber bell frame and single bell.
3. Brickwork is generally in good order. Isolated open joints to the head of the louvred openings.

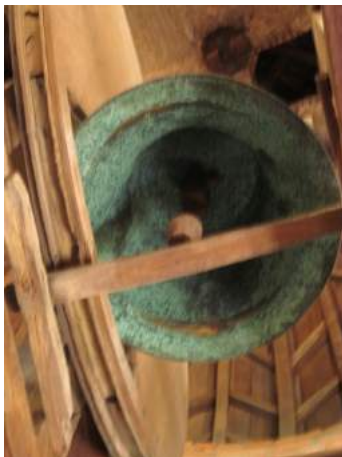
1. There is a single bell which appears to be in good order.
